### INSPECTION REPORT

1420 Example Way, Tampa,  
FL 33602

SAMPLE-1420-Example-Way

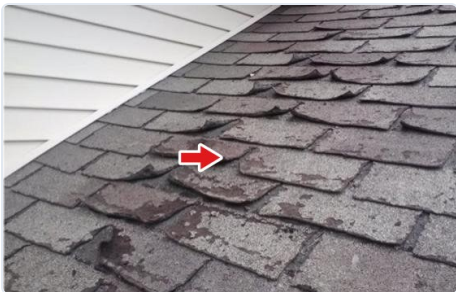
1.0 Item 1 (Picture)  
Damaged/lifted shingles with granule loss need to be evaluated/repared by a licensed roofing contractor

- Damaged/lifted shingles with granule loss need to be evaluated/repared by a licensed roofing contractor

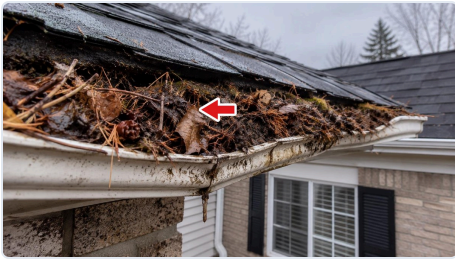
#### 1.3 Item 1 (Picture)

- Clogged gutter filled with debris needs to be evaluated/cleaned

Clogged gutter filled with debris needs to be evaluated/cleaned

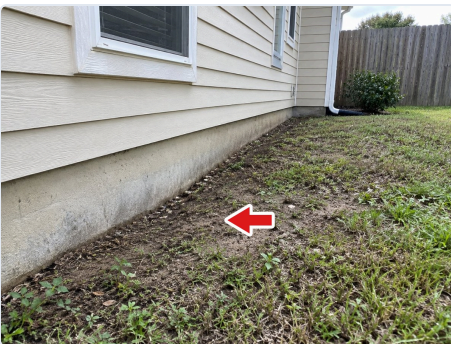
##### 2.4 Item 1 (Picture)

- Negative grading sloping toward the home needs to be evaluated/repared

Negative grading sloping toward the home needs to be evaluated/repared

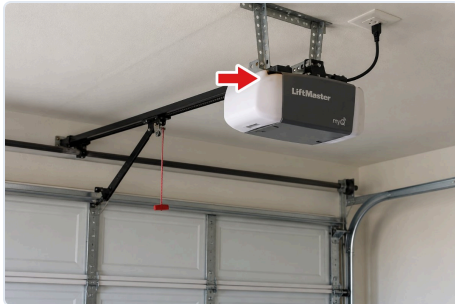
###### 3.5 Item 1 (Picture)

- The garage door operator did not reverse on contact with an obstruction. Recommend adjustment or repair by a qualified contractor

The garage door operator did not reverse on contact with an obstruction. Recommend adjustment or repair by a qualified contractor

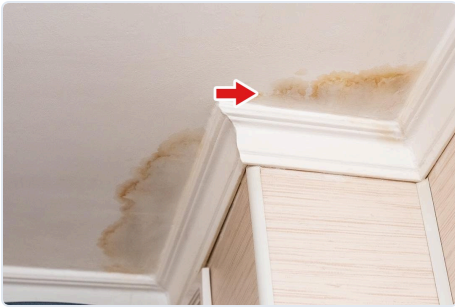
##### 4.0 Item 1 (Picture)

- Water staining on ceiling needs to be evaluated/repared

Water staining on ceiling needs to be evaluated/repared

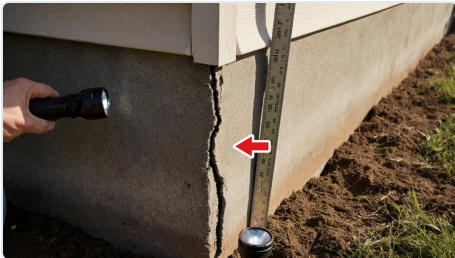
##### 5.0 Item 1 (Picture)

- Cracked foundation wall needs to be evaluated/repared by a licensed contractor

Cracked foundation wall needs to be evaluated/repared by a licensed contractor

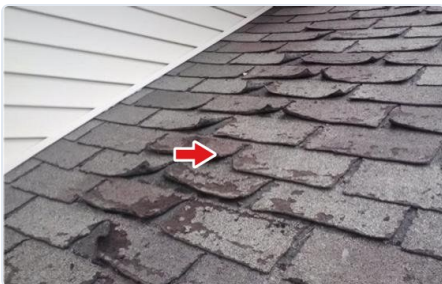
#### 1.0 Item 1 (Picture)

- Damaged/lifted shingles with granule loss need to be evaluated/repared by a licensed roofing contractor

Damaged/lifted shingles with granule loss need to be evaluated/repared by a licensed roofing contractor

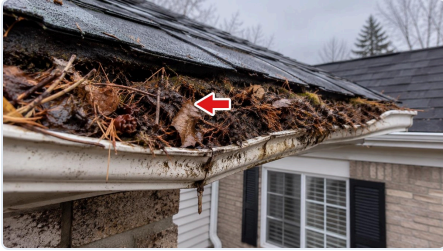
#### 1.3 Item 1 (Picture)

- Clogged gutter filled with debris needs to be evaluated/cleaned

Clogged gutter filled with debris needs to be evaluated/cleaned

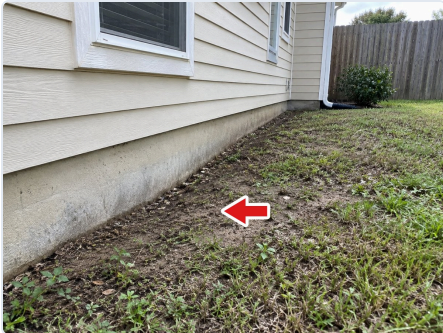
#### 2.4 Item 1 (Picture)

- Negative grading sloping toward the home needs to be evaluated/repared

Negative grading sloping toward the home needs to be evaluated/repared

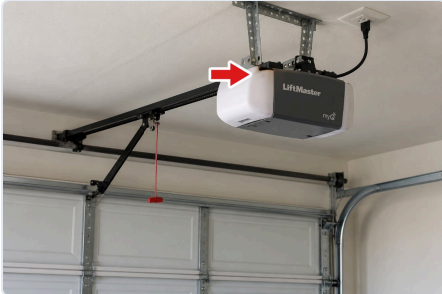
#### 3.5 Item 1 (Picture)

- The garage door operator did not reverse on contact with an obstruction. Recommend adjustment or repair by a qualified contractor

The garage door operator did not reverse on contact with an obstruction. Recommend adjustment or repair by a qualified contractor

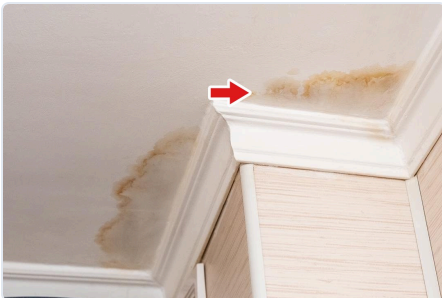
#### 4.0 Item 1 (Picture)

- Water staining on ceiling needs to be evaluated/repared

Water staining on ceiling needs to be evaluated/repared

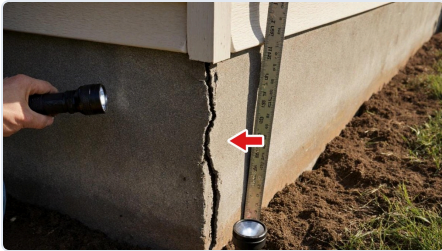
#### 5.0 Item 1 (Picture)

- Cracked foundation wall needs to be evaluated/repared by a licensed contractor

Cracked foundation wall needs to be evaluated/repared by a licensed contractor

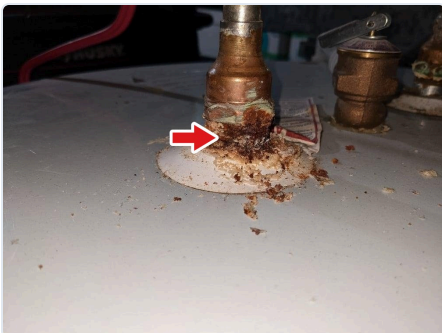
#### 6.2 Item 1 (Picture)

- Corroded/leaking water heater supply connection needs to be evaluated/repared by a licensed contractor

Corroded/leaking water heater supply connection needs to be evaluated/repared by a licensed contractor
